**Loss Prevention Bulletin - AVA/2014/0013**

**Jan 08, 2014**

**FENDER DAMAGE AT RORO BERTH**

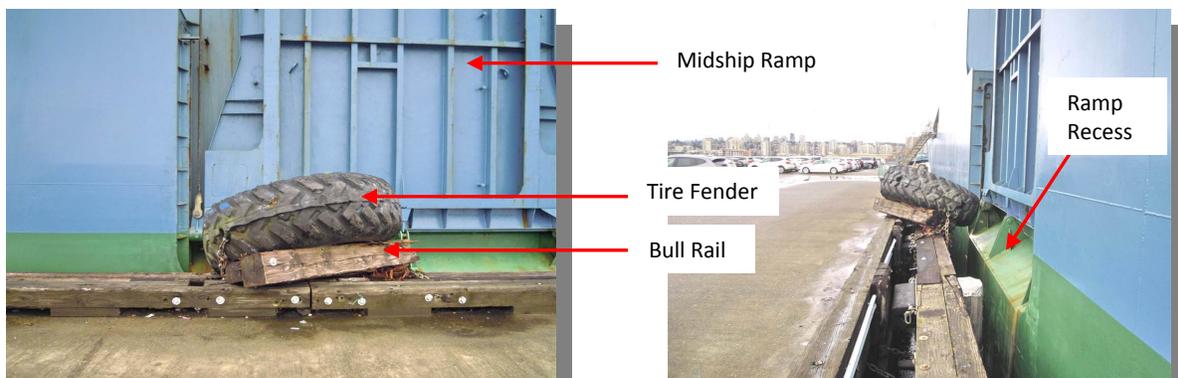
Recently in almost two identical incidents involving PCC (Pure Car Carriers) at the Annacis Auto Terminal operated by WWL Vehicle Services Canada, Ltd, the shore fender system suffered damages to the timber bull rail and fender attachment in way of distortion / bent bolts and steel plate and cracking of the bull rails (timber beams).

On both occasions the damage was caused when the starboard midship ramp of the vessel got caught / stuck in the ramp recess during the rising tide. The up thrust force was sufficient to cause the bull rail to break under pressure.

Damage to quayside due to the fender getting caught in the ramp recess

The Master should ensure the midship ramp is not facing any rubber tire fender when the vessel is in 'position' at the dock. The final position of the vessel should be adjusted keeping the fender fore or aft of the midship ramp so that it does not get caught in the ramp recess during the rising tide.

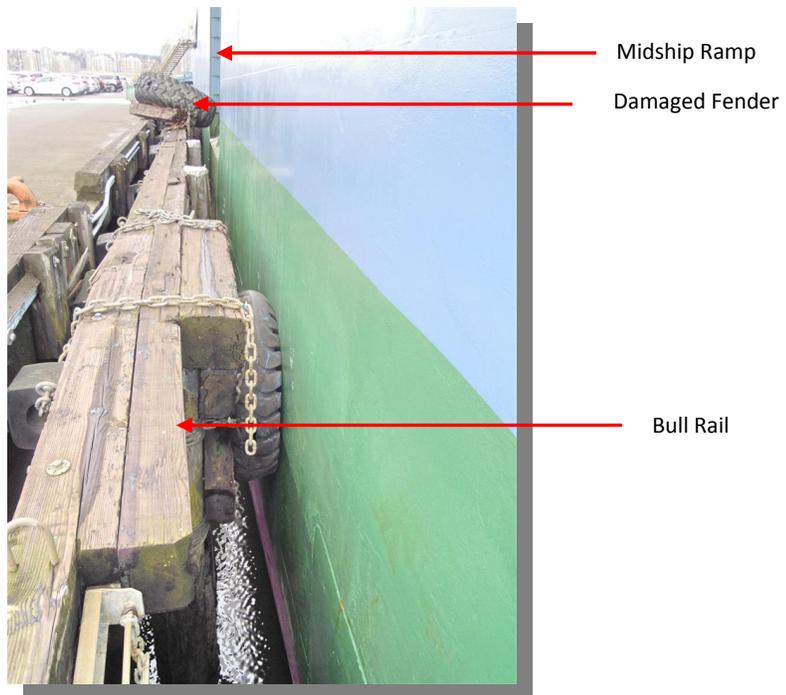
For comparison -showing the original positioning of the fender in normal conditions
